LONG RIDGE DAM

NDI I.D. NO. PA-01022
PENNDER I.D. NO. 52-185

PHASE I INSPECTION REPORT
NATIONAL DAM INSPECTION PROGRAM

SEPTEMBER 1981

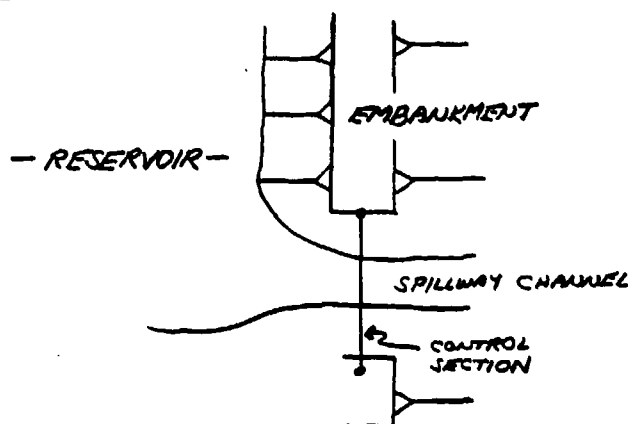
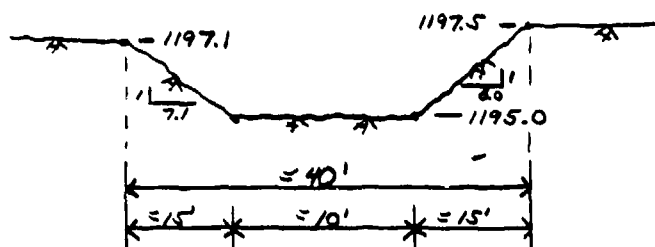
SPILLWAY CAPACITY

- SKETCHES BASED ON FIELD SURVEY.
